CITY OF BALTIMORE WET SMOKE AND DYED I	Page 1 of 3	
Sewershed: Low Level Subsewershed: 44	Company: REI/DRAYCO	Date: 09/02/2008
Test Type: Smoke	Ground Condition: Dry: X Damp:_ Wet:_	Supervisor: E.R. Crew: 04
Manhole ID: S19O010MH	Test ID: 1029-582	Notifications Made:X_ Residents, Fire, 311

CITY OF BALTIMORE SMOKE TESTING OBSERVATION SUMMARY LOW LEVEL SEWERSHED

BALTIMORE CITY PROJECT 1029 REI/DRAYCO

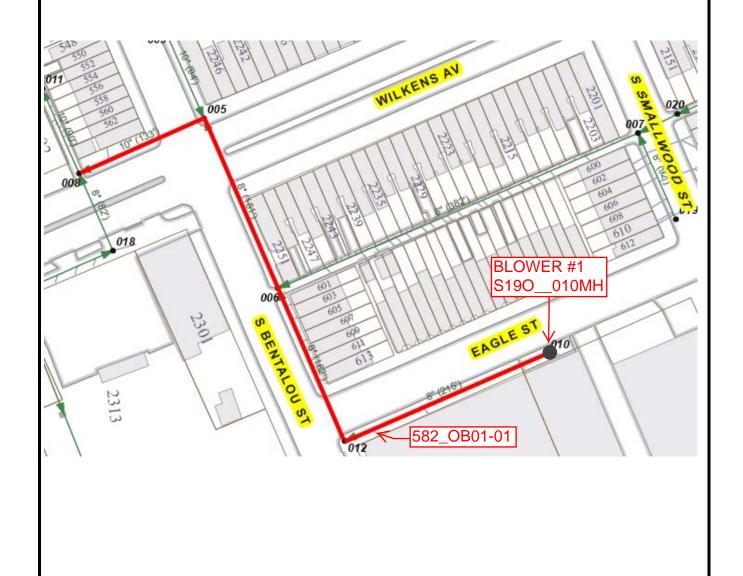
Field Sketch: (Show all manholes with numbers, blower placement location, sandbag or isolation locations, street names, building addresses and locations, defect locations and photograph numbers)

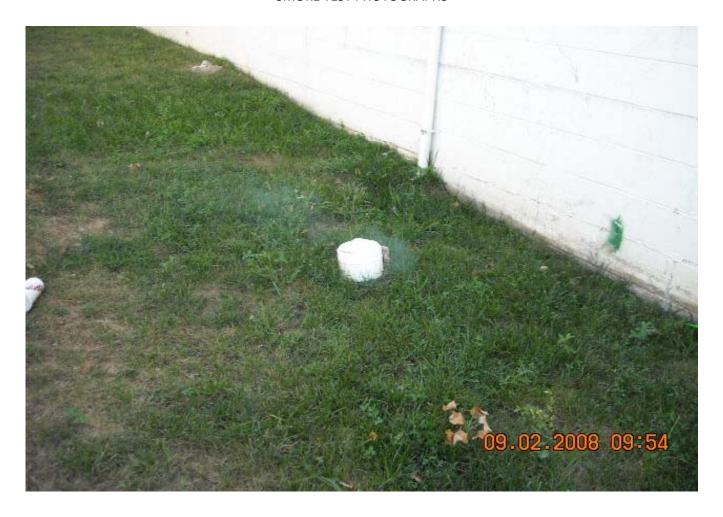
Photograph No: OB01-01 Filename: 1029-582_OB01-01.jpg

Unique Test ID: 582	<u>P</u> Date:	09/02/2008	Basin: LL - 44	Manhole ID: S19O010MH
Defect No: OB01	Supervisor: E.R.	Crew: 04		Dye Test Recommended: N

Location: 621 S. BENTALOU ST.

Source Type: 03 Service Line Sector: 02 Private

Location: 09 Yard - Side Severity: 03 Moderate Drainage Area: 5

Comments: SMOKE IS COMING FROM THE GROUND AROUND THE CLEANOUT CAP.
